**NISTIR 5488**

# **Performance of HUD-Affiliated Properties During the January 17, 1994 Northridge Earthquake**

August 1994  
Building and Fire Research Laboratory  
National Institute of Standards and Technology  
Gaithersburg, MD 20899

*Prepared for:*  
U.S. Department of  
Housing and Urban  
Development

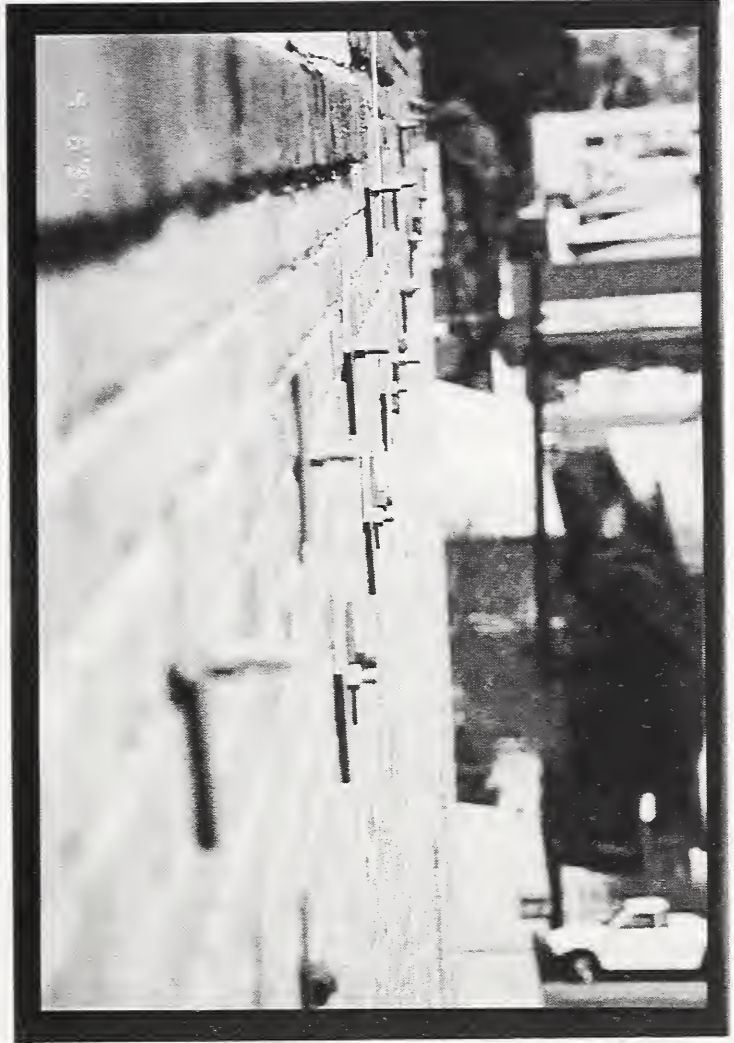
Almost all of the unreinforced masonry buildings in the sample were observed to have been rehabilitated prior to the earthquake using bolts, outfitted with steel plate washers, that pierced the masonry at the lines of the floors and roof (fig. 8). Parapet bracing was also observed (fig. 9). The City of Los Angeles has a mandatory seismic rehabilitation ordinance for unreinforced masonry buildings constructed prior to 1934 that applies to apartment buildings that have five or more living units. Surrounding jurisdictions do not have similar mandatory requirements. In some instances the Los Angeles ordinance, known colloquially as Division 88, requires the addition of new cross walls, supplementary vertical supports, and other strengthening actions in addition to the commonly required through-bolts and parapet bracing. While the BFRL investigators did note the presence of through-bolts and parapet bracing, they did not determine whether the rehabilitation effort conformed with the requirements of Division 88.

*Figure 8 Pre-earthquake seismic rehabilitation of unreinforced masonry buildings typically included face plates and through-bolts anchoring the walls to the floor and roof joists.*

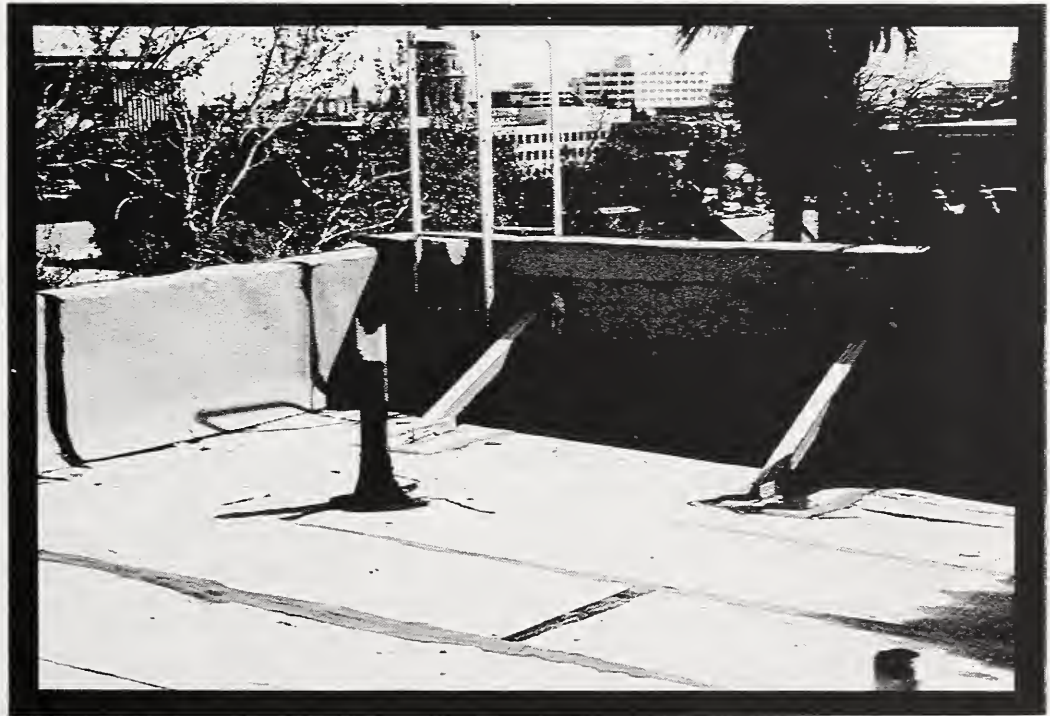
*Figure 9 Unreinforced masonry buildings that had been rehabilitated prior to the earthquake typically had had their parapets braced.*

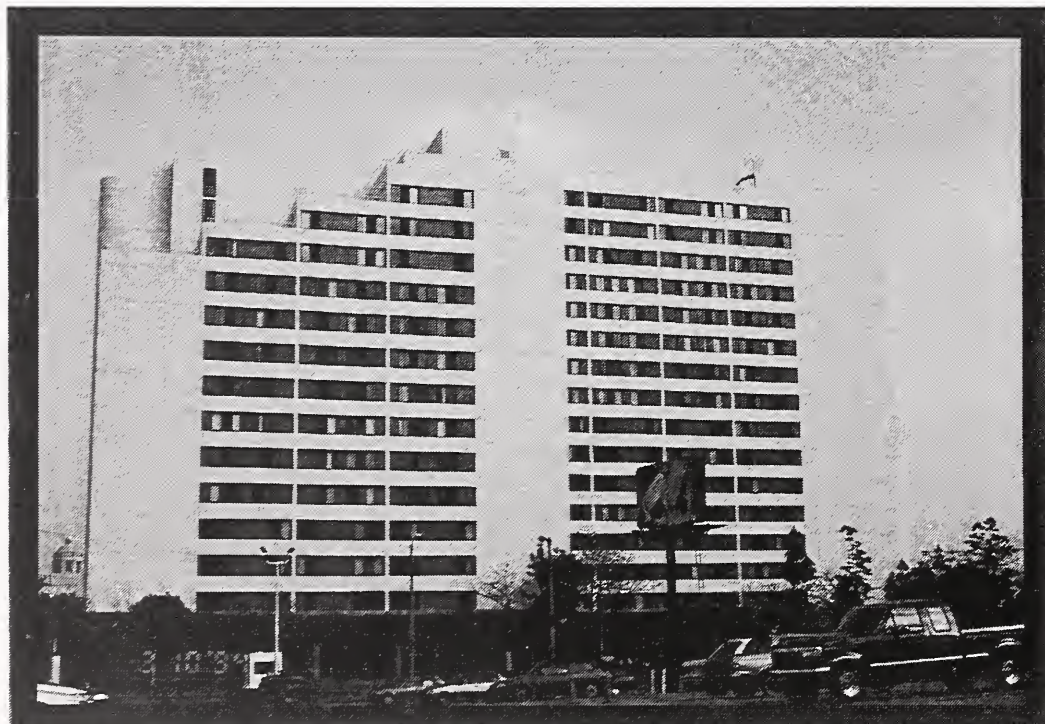
There were no steel frame buildings in the candidate group of damaged buildings. One of the buildings in the inventory was originally misidentified as a steel frame structure. The building manager had stated that Cathay Manor, a 16-story building about 33 km from the epicenter, had a steel frame. When the BFRL investigators arrived at the site, the plans of the structural system were not available. The investigators found no evidence to suggest that the building was a steel frame building. Their observations led them to conclude that the building was a concrete shear wall building, and it has been classified as such in this study (fig. 10). The building suffered cracks in the shear walls and nonstructural walls similar to those observed in concrete buildings.

*Figure 10 Cathay Manor, a 16-story building about 33 km from the epicenter, was determined to be a concrete shear wall building.*

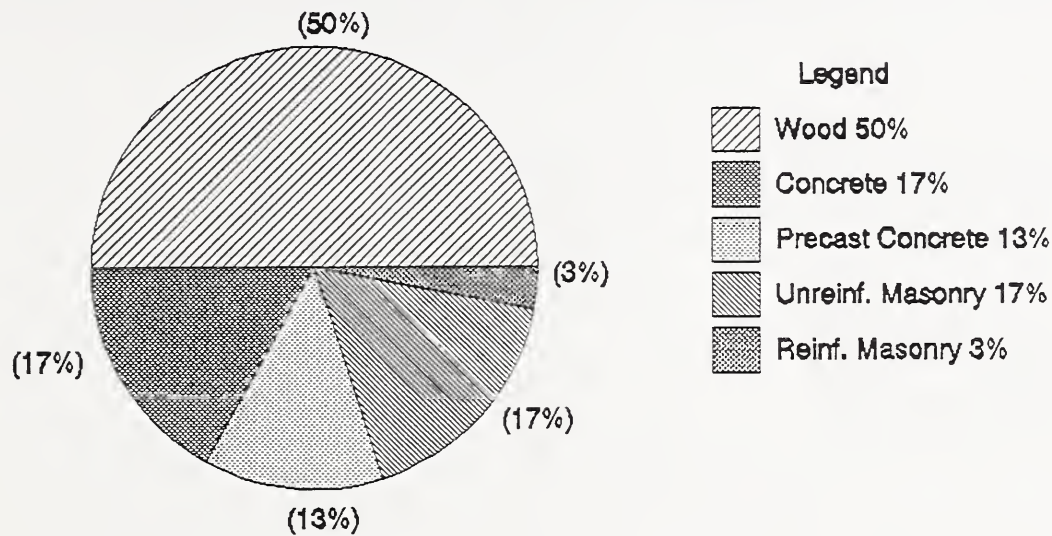
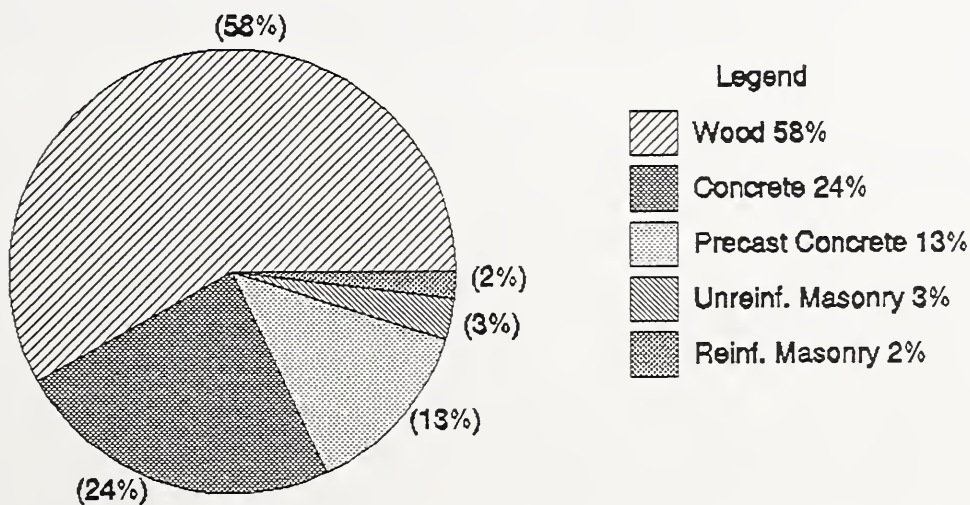
Common types of damage observed are described below, grouped by building structural system. Figure 11 illustrates the distribution in the sample of structural systems, by site and by number of living units.

Figure 11 Above, distribution of structural types in the buildings in the sample when tabulated by site; below, distribution of structural types by number of living units.

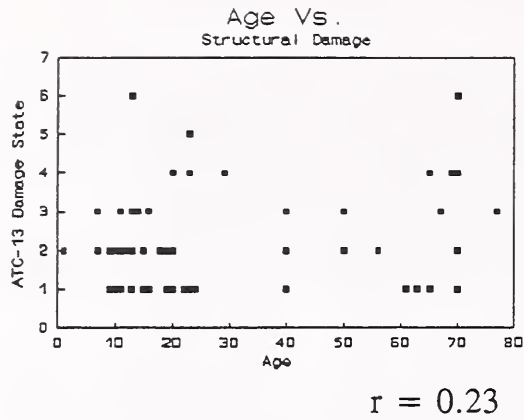
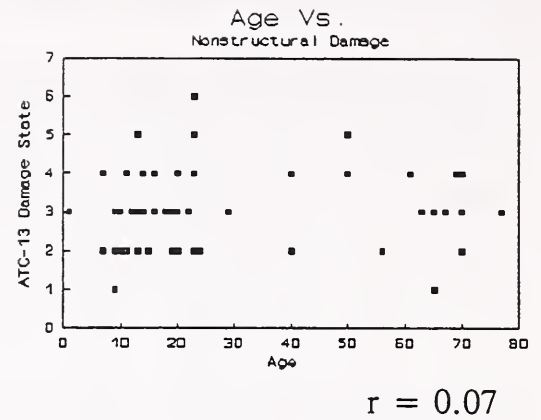
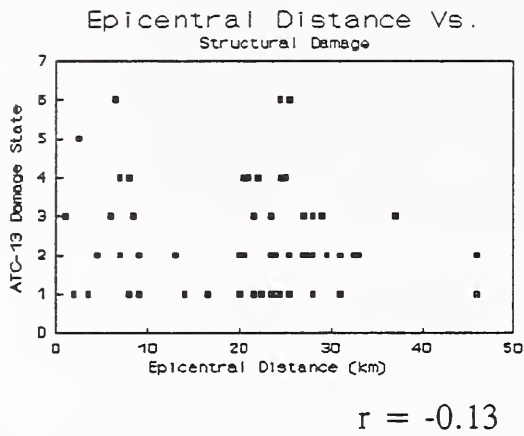
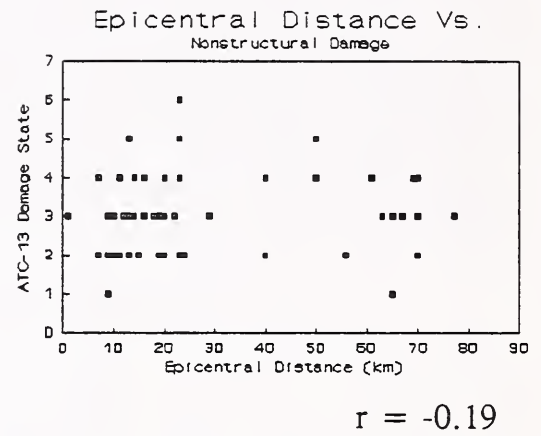
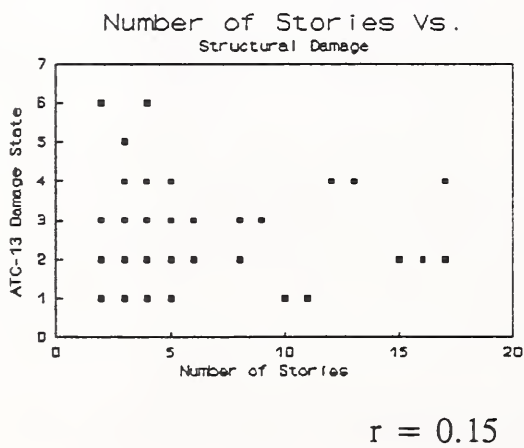
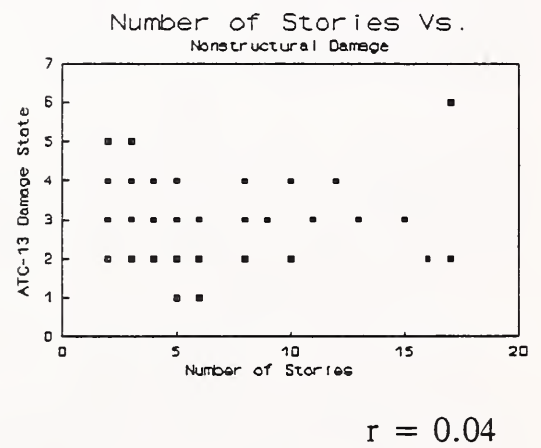
Figure 29  
Scatter Plots and Coefficients of Correlation  
Age, Epicentral Distance and Number of Stories  
Compared to Structural and Nonstructural Damage States

Scatter plots were produced, evaluating each site as one data point. The scatter plots showed a wide distribution of damage states for each of the variables considered (fig. 29). Note that, as can be seen from the data in Table C, each of the dots shown in figure 29 may represent more than one data point. Regression analysis confirmed that no statistically valid trends existed in the data for age, number of stories, or epicentral distance (considered individually and ignoring the influence of the other parameters) when measured against structural and nonstructural damage states. The correlation coefficient,  $r$ , was greatest for the correlation between age and structural damage, but, with a value of only 0.23, the correlation cannot be considered significant. The correlation coefficient  $r$  always has a value between -1 and 1; these values imply perfect correlation. A value of zero indicates no correlation whatsoever.

It is possible that strong trends do exist in more narrowly defined groupings of data which consider the combined effects of multiple variables, for example, age-to-damage state correlations for each different structural system, rather than for all systems considered together. However, the relatively limited number of data points available from this study does not justify more finely partitioned analyses. Given a larger set of data points, trends may well become apparent.

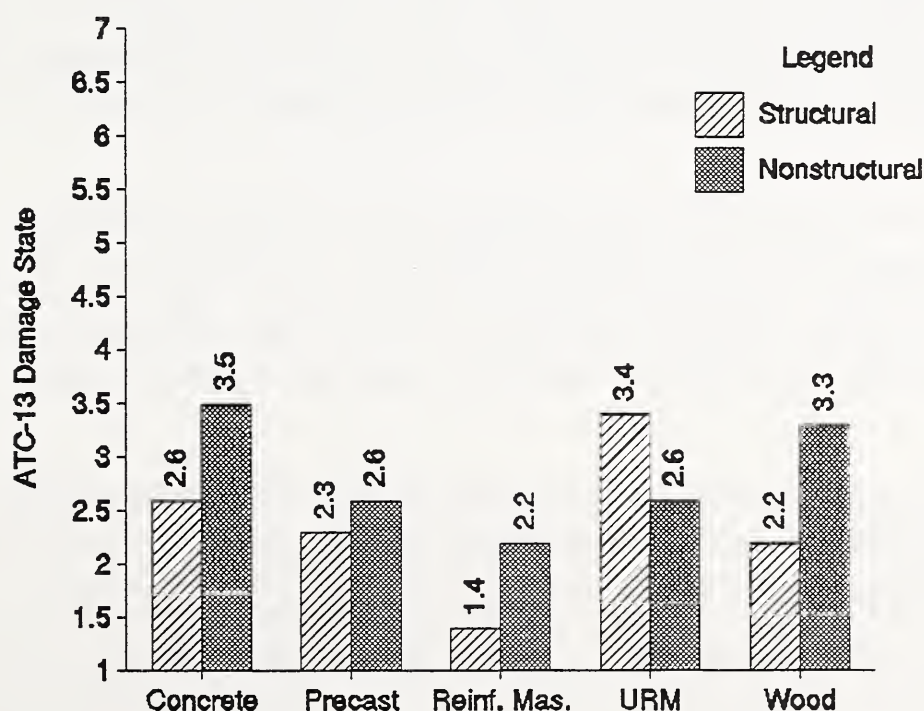
Figure 30 Bar graph showing weighted averages of ATC-13 structural and nonstructural damage states by structural system.

The highest average damage state was 3.5, for non-structural damage in concrete buildings, which is between "light" (1%-10%) and "moderate" (10%-30%) damage. The lowest average value, 1.4, for structural damage in reinforced masonry buildings, is between damage rated as "none" (0%) and "slight" (0%-1%).
